# CRASH INJURY EVALUATION

SUMMARY EVALUATION

U. S. ARMY HU - 1A

FLIGHT SAFETY FOUNDATION, Inc.

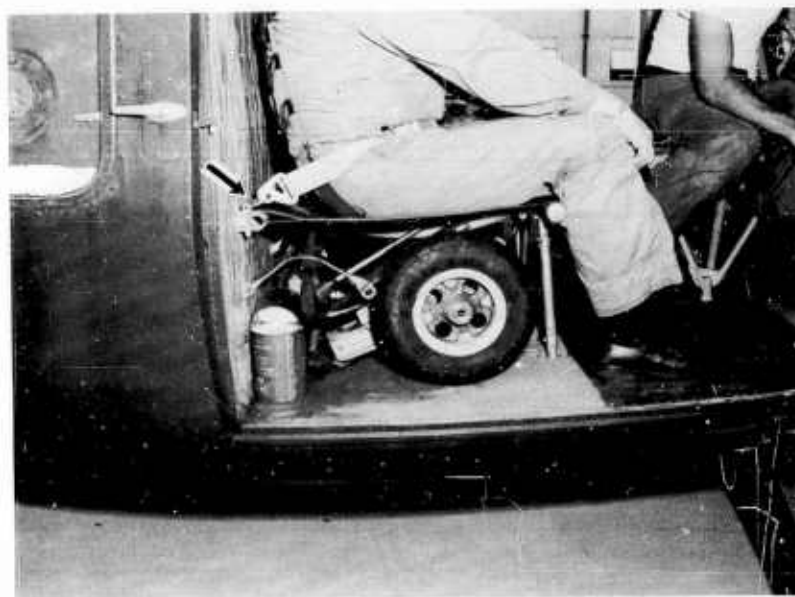
The incorrect belt installation also permits the seat belt to "ride up" and could cause rib and/or chest injuries due to flexing over the belt buckle, in addition to possible spinal injuries.

Figure 53. The incorrect method of attaching the safety belt to the "O" ring is depicted by the arrow. Note that the belt crosses the occupant at approximately 90°.

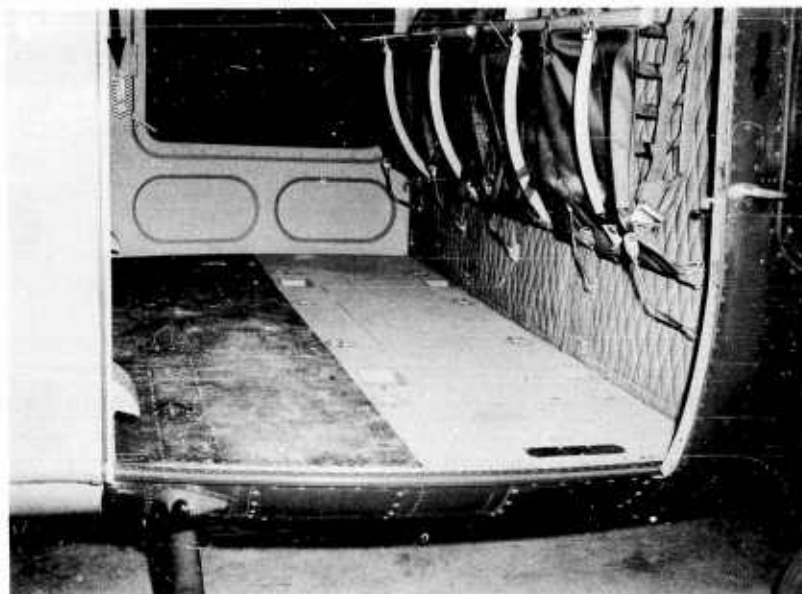
Figure 56. Absence of exterior door operating instructions. The arrow on the left depicts the interior operating instructions. The arrow on the right denotes the absence of exterior door operating instructions.
